Bid: Freedom Street Roadway and Bridge Rehabilitation Project

Subject: ADDENDUM #1

DOCUMENT – MassDOT ROUTINE INSPECTION (August 3, 2010) 11 pages

FREEDOM STREET
OVER MILL RIVER
CONCRETE REPAIR DETAILS
HOPEDALE, MASSACHUSETTS

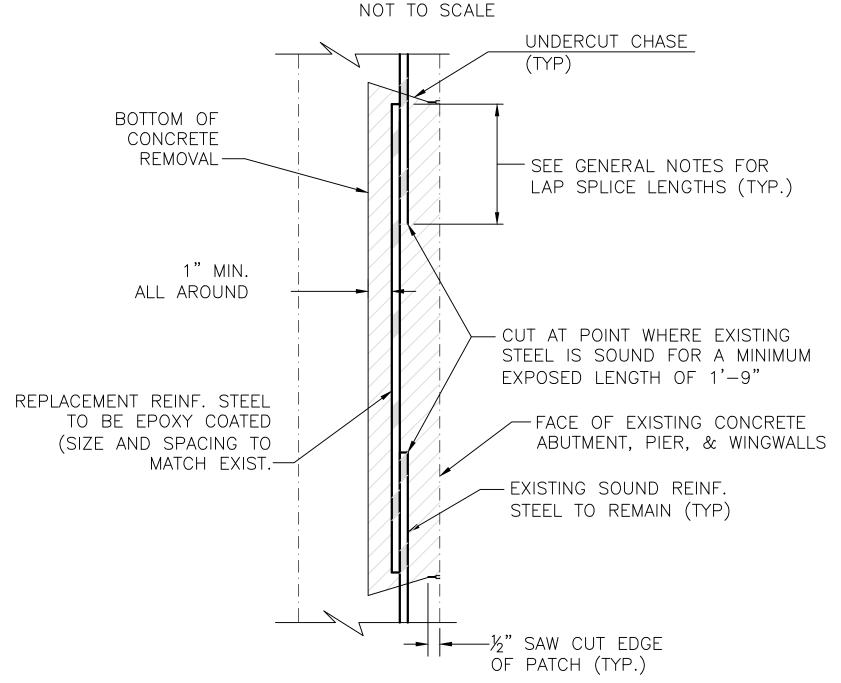
# DETAIL 4: SHALLOW DEPTH SUBSTRUCTURE REPAIR

## DEPTH OF REMOVAL REINF. STEEL NOT ENCOUNTERED BLAST CLEAN SURFACE BEFORE PLACING PATCH MATERIAL — - VOID AREA OF EXISTING SCALE OR SPALL LIMITS OF DETERIORATED CONCRETE DETERMINED IN -REMOVE DETERIORATED CONCRETE TO FIELD BY CONTRACTOR AND SOUND CONCRETE. APPLY BONDING AS DIRECTED BY THE MATERIAL PER NOTE 5. ENGINEER ----FACE OF EXISTING CONCRETE ABUTMENT, PIER, & WINGWALLS IF 1%" OR LESS REPAIR WITH CEMENTIOUS MORTAR. IF GREATER THAN 1½" REPAIR WITH 4000 PSI -½" MIN. → 1" MAX. $\frac{3}{8}$ " - 660 CEMENT CONCRETE -IF REINFORCING ENCOUNTERED USE PARTIAL DEPTH REPAIR 为" SAW CUT EDGE OF PATCH (SEE NOTE 11) ─────

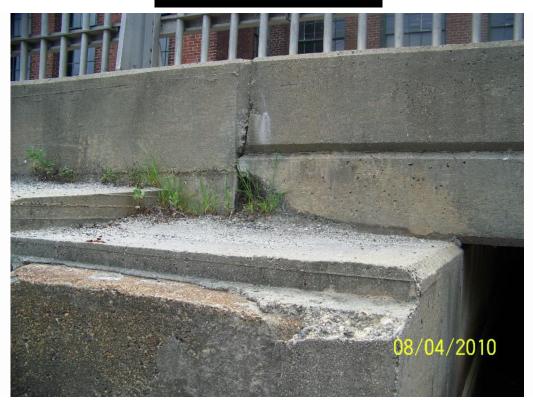
There is an approx. 7 in. high x 7 in. wide x 3 in. deep triangle shaped spall to the outside end of the deck slab, at the Northeast corner. **See photo #1.** There is a up to 4 ft. long x 12 in. high x 3 in. deep spall with exposed rusting rebars, to the South outside face of the deck slab, in span #2, exposing the granite curb. **See photo #2.**

Photo 1: Spall to the Northeast outside corner of the deck slab.

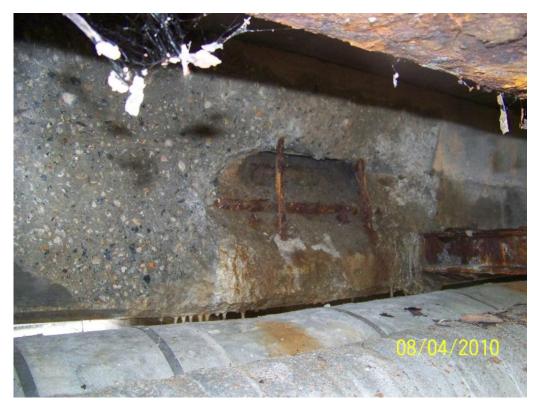
Both parapets have several short vertical hairline cracks with light efflorescence. There is an up to 4 ft. long x approx. 14 in. high x 3 in. deep spall with exposed rusting rebars, to the South parapet, in span #2, above the spall to the South face of the deck slab. **See photo #2.**

Photo 2: Spall to the outside face of the deck slab and parapet, in span #2.

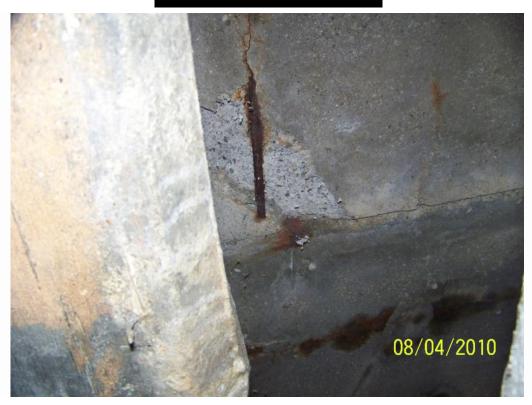
The sidewalk wearing surface has been repaved with a bit. conc. overlay. The underside of the sidewalk has full width transverse rust staining and some small areas of spalling throughout. There is a 12 in. x 6 in. x 2 in. deep spall with exposed rusting rebar, to the sidewalk underside in span #1. **See photo #3.** Re: Item #59.4 for sidewalk beam remarks.

Photo 3: Spall to the underside of the South concrete sidewalk, in span #1.

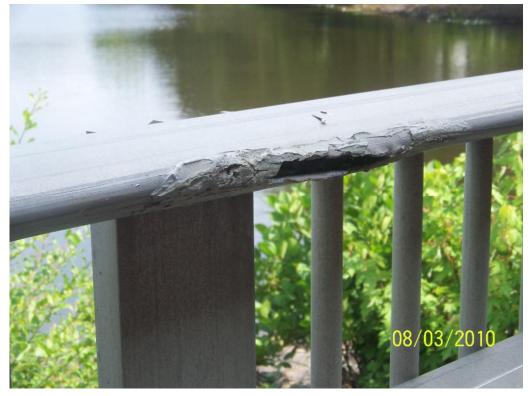
Photo 4: Small tear to the top AL-3 approach rail, at the Northeast corner of the bridge.

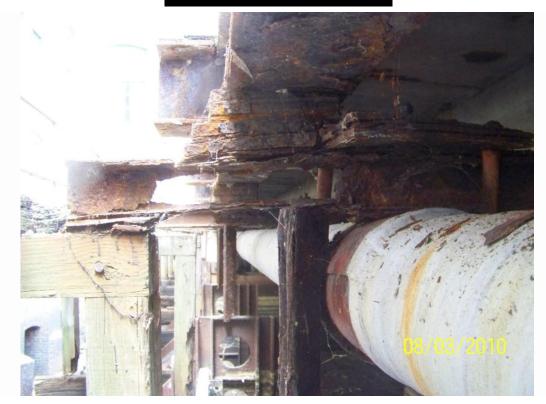
The utility assembly (for gas & water) is built-up from the dam below. Consisting of 4 in. high steel "I" beams that are placed transversely supported by the dam at one end. These "I" beams have 100% section loss to the webs of #1, #5, #6, #7, and #9, the remainder have severe rust flaking of steel and section loss. "I" beam #9 has 100% section loss to the bottom flange, the remainder have severe rust flaking and section loss. **See photos #5 & #6.** The utility support hanger assembilies have severe rust flaking to the plates and nuts, some with 100% section loss. The inside utility (water) is missing some of the "U" bolts.

Photo 5: Heavily corroded utility supports at the South side of the bridge.

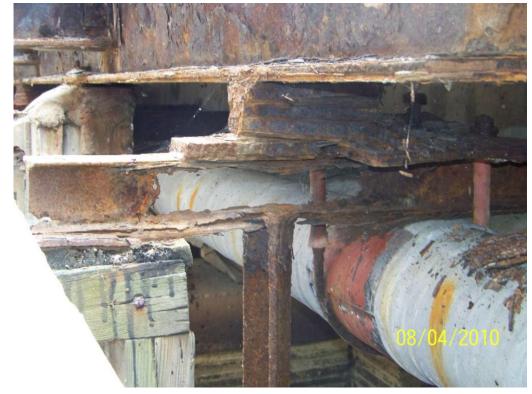
Photo 6: Heavily corroded utility supports at the South side of the bridge.

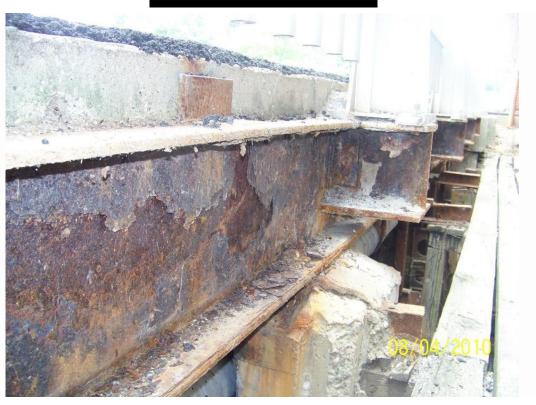
The sidewalk is supported by a 14 in. high steel beam along the entire length of the South side of the sidewalk. This beam has moderate to heavy rusting, rust flaking and corrosion of steel. **See photo #7**.

Photo 7: Heavily rusted and corroded South sidewalk fascia beam.

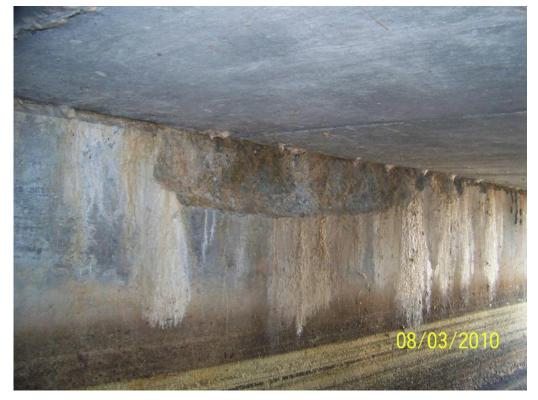
Approx. 80% of the top of the West breastwall shows moderate spalling up to 8 in. high x 2 in. deep with heavy efflorescence and light rust staining along the breastwall/bridge seat area. **See photo #8.** The West breastwall has a full height crack up to 3 in. wide x 4 in. deep. There is an approx. 5 ft. high x 3 ft. wide x up to 4 in. deep spall at the South end of the West breastwall. The East breastwall has moderate to heavy efflorescence and light rust staining throughout the top. Both breastwalls have minor waterline abrasion. The bottom North corner of the East breastwall shows concrete deterioration and is undermined with up to up to 4 in. penetration. This concrete deterioration and undermining extends throughout the bottom of the channel wall between the structure and the adjacent sluiceway. **See photo #9.**

Photo 8: Spalling along the top of the West breastwall.

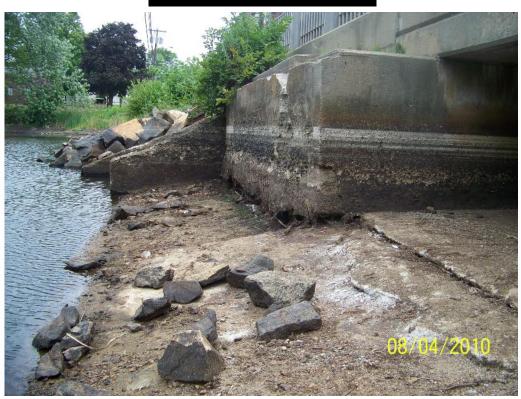
The downstream Southeast dry laid stone channel wall has several missing stones causing a large void adjacent to the back of the East breastwall. This void is undermining the South end of the East concrete breastwall approx. 2 ft. **See photo #12.** The Southeast channel wall shows several other isolated small voids throughout. There is concrete deterioration and undermining throughout the bottom of the channel wall (dam) between the structure and the adjacent sluiceway, at the Northeast corner of the bridge. **See photo #9.**

Photo 9: Concrete deterioration and undermining to the North end of the East breastwall and channel wall.

The intent of this detail is to remove loose material from within the void, to the extent possible, and fill the void with 4000 PSI, 1.5 In., Cement Concrete. REVETMENT DETAIL has been revised, see attached revised Drawing Sheet 11 of 14.

In addition, attached for information only is the August 3, 2010 Routine Inspection Report prepared by MassDOT at a time when the water level was low enough to visibly see the area in question (Photo. 9).

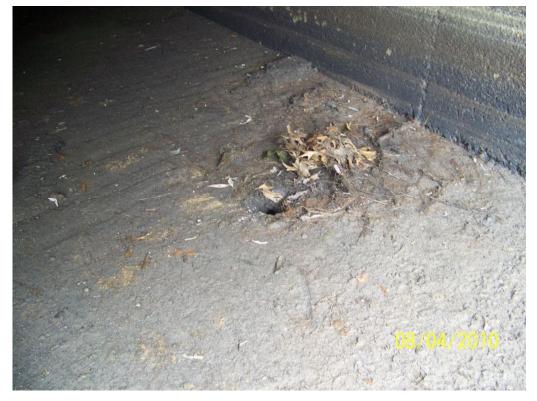
There is a 3 in. diameter hole to the concrete floor in span #2, near the North end, with at least 1 ft. of penetration. **See photo #10.** There are several full width cracks to the concrete floor, in all three barrels. The Concrete apron has settled slightly along the floor of the structure, at the North side of the bridge. **See photo #11.**

Photo 10: 3 in. diameter hole to the concrete floor in span #2.

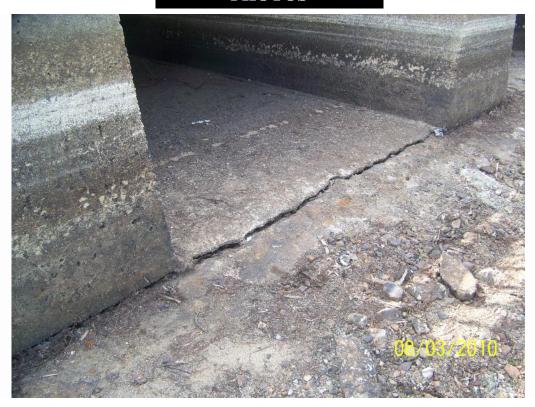
Photo 11: Concrete apron settled along the floor of the bridge, at the North side.

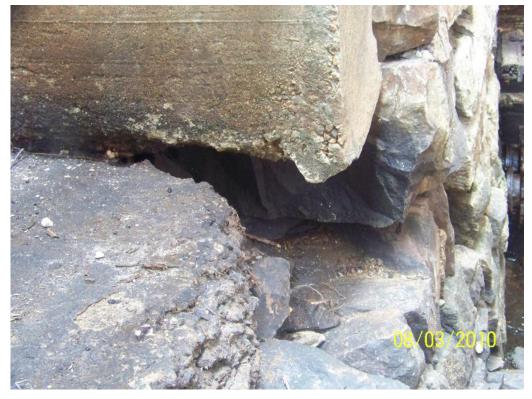
Photo 12: Missing stones and voids to the Southeast channel wall, adjacent to the East concrete breastwall.
